BOB GRAHAM SUNSHINE SKYWAY BRIDGE STAY CABLE PAINTING PROJECT – LESSONS LEARNED

Jose (Pepe) Garcia, P.E.
District 1 & 7 Structures Maintenance Engineer
Florida Department of Transportation
Tampa, FL

Abstract: The Sunshine Skyway Cable Stay Bridge is the signature bridge in the State of Florida. During 2004 the decision was made to repaint the stay cables for corrosion protection and aesthetic issues. The authors participated in a coatings condition assessment, plan development for refurbishing the coating system, and project execution. This paper identifies areas that made the Sunshine Skyway Bridge a challenging project such as: coatings condition assessment, paint specifications, access, containment system, execution, and final acceptance.

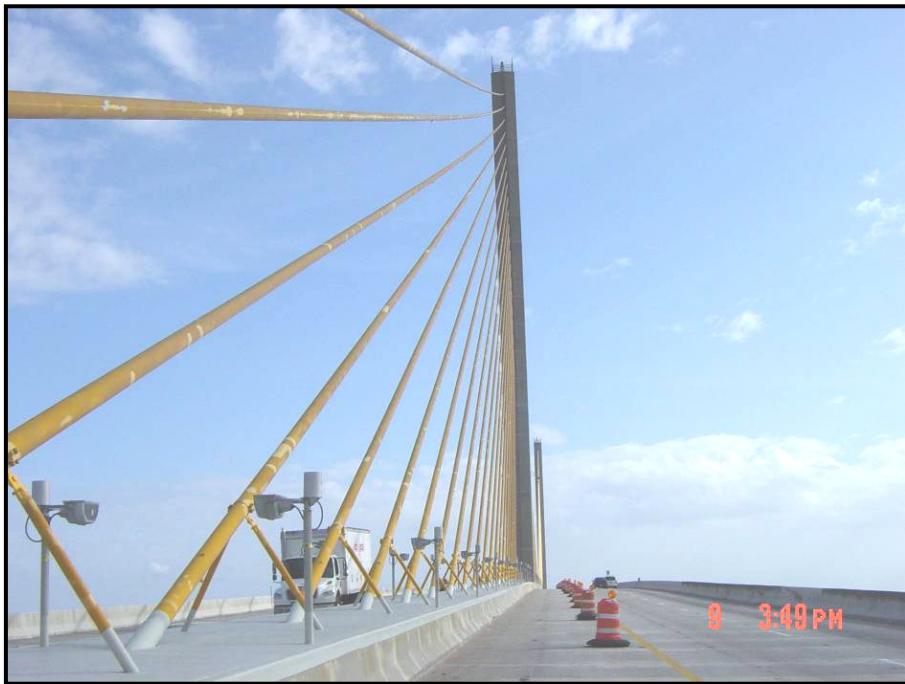
The two primary objectives of the project were to provide extended corrosion protection of the stay cables by use of protective coatings and at the same time to impart an aesthetically pleasing view for the public. Although not the main reason for the project, aesthetics was a factor since the appearance of the stay cables has been an issue based on comments from the public for several years. Figure 1 shows the general appearance that has had the public questioning the splotchy appearance that was a result of a spot repair job from the late 1990's.

Figure 1- Sunshine Skyway pre-project typical spot coat appearance.

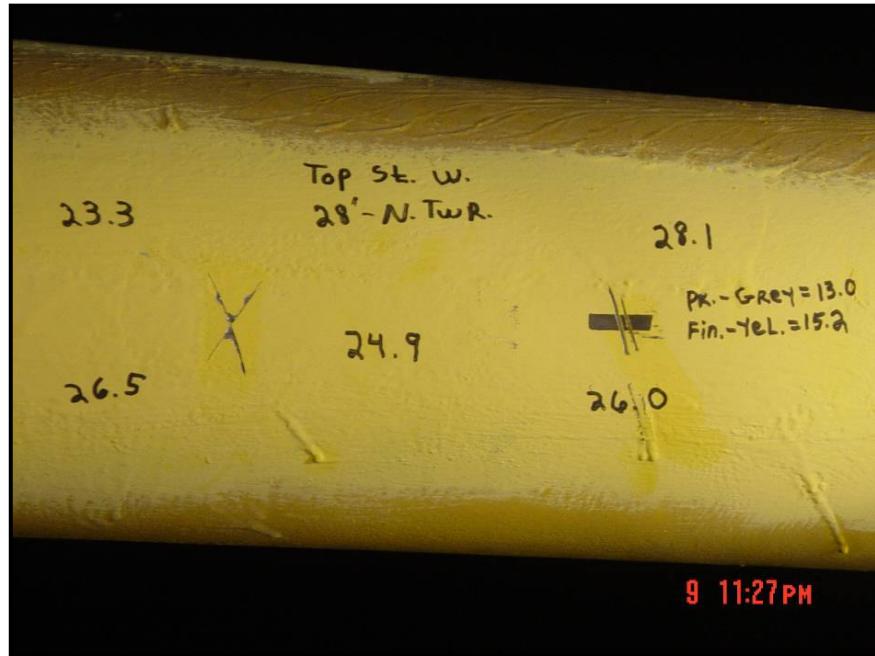
The assessment was performed in December of 2005. Figures 2 and 3 show typical examples of the test area findings.

Figure 2- Typical test area for the assessment.

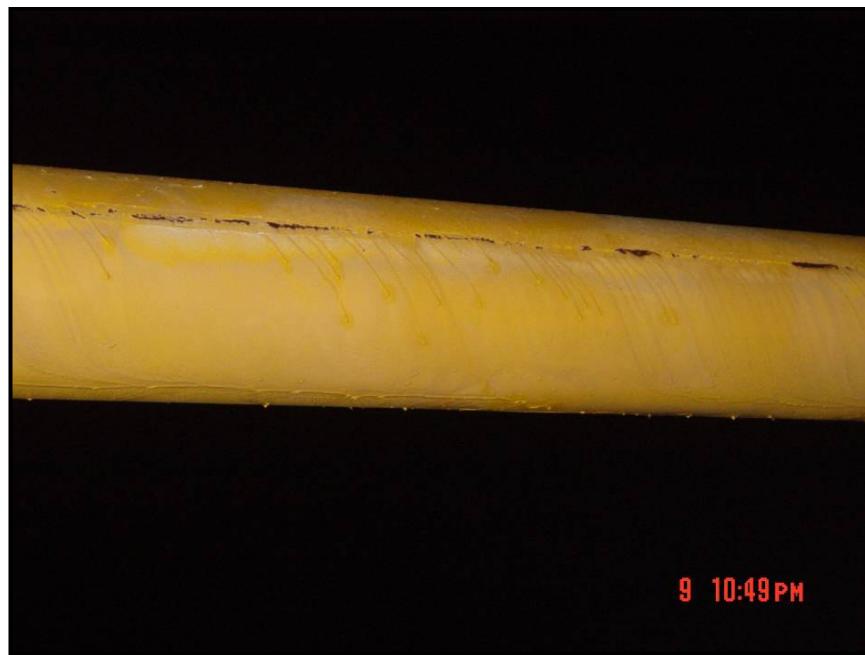
Figure 3- Corrosion typical of the condition on stays in the upper areas at project start-up.

- The previous coating repairs did not include a zinc primer. The repair coatings consisted of only an additional yellow topcoat.
- The adhesion was generally poor.
- The dry film thickness range was 18 mils to 28.2 mils and averaged 19.0 mils.
- Hazardous heavy metals were found
- The generic coating system was identified as epoxy base coat and an aliphatic urethane topcoat.

The topcoat of the repaired and original coatings was deteriorated which included chalking and disbondment. The topcoat was also brittle. Based on these findings the maintenance painting options were limited and it was concluded the most cost effective approach would involve removing and replacing the existing coating system. Another consideration in choosing full removal and replacement was the accessibility of the stays. The designers and owners were aware that access would be an issue and a costly part of the project so designing a system that would give long-term corrosion protection, while maintaining good aesthetics, was needed. These reasons also favored the choice of full removal and replacement.

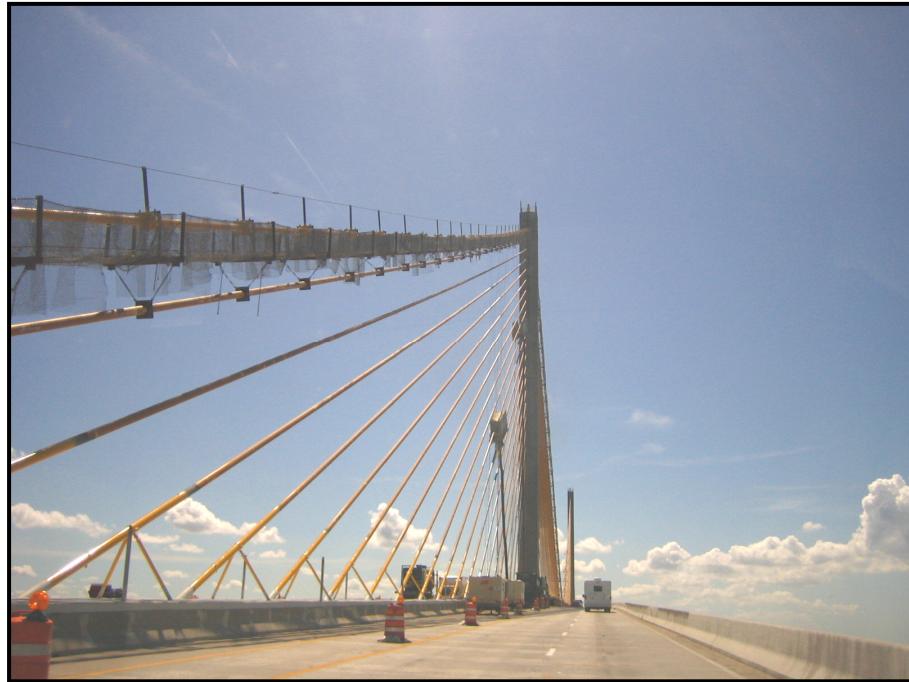
The final plan was developed by a specialty engineer and involved rigging on the two highest stay cables (#20, #21) at each of the arrays. This rigging allowed for the surface preparation and painting of Stay #21 in containment, as shown in Figure 5, and it also allowed for the use of a two point suspension scaffold system. An independent third line was used for fall protection for the construction crew. The suspension scaffolding system consisted of two platforms that moved vertically up and down on retaining cables. This review and processing system involved more coordination from the project team. The specialty engineer had to visit the site and submit a signed and sealed safety inspection letter

prior to use of the scaffolding by the contractor and the inspection team. The rigging on Stay #21 allowed for the inspection of all welds on Stays #21 after blast cleaning. This was a much needed inspection to help assure that no noticeable defects of the welds had occurred when checked by magnetic particle testing.

Figure 5- Rigging on Stay cables 21 & 20

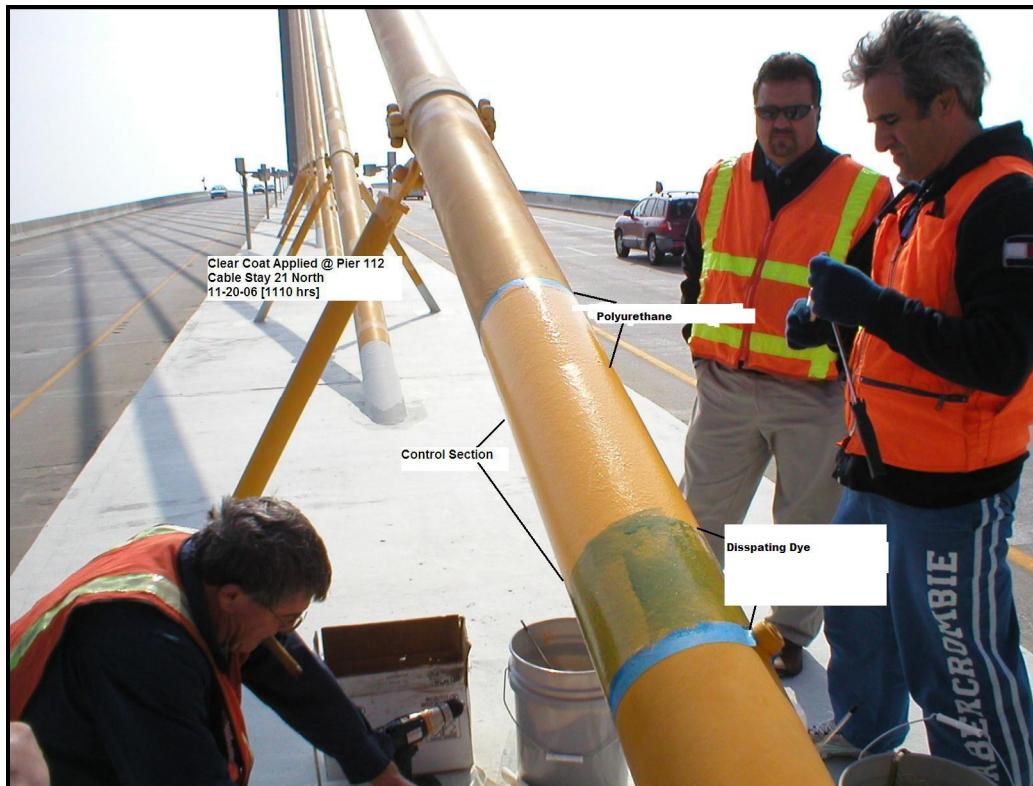
The clear coat had a blue color dissipating dye identify the coverage limit during application and inspection. The first concern was if the dye would really totally dissipate. The contractor, manufacturer and the CEI team did test areas before the project began to ensure the dye would truly disappear within the 72 hour period as required by the specification. See Figure 8 & 9 below. The clear coat dissipated in 54 hours on the test patch, which was well within the required period.

Figure 8 – Application of clear coat with dissipating dye.

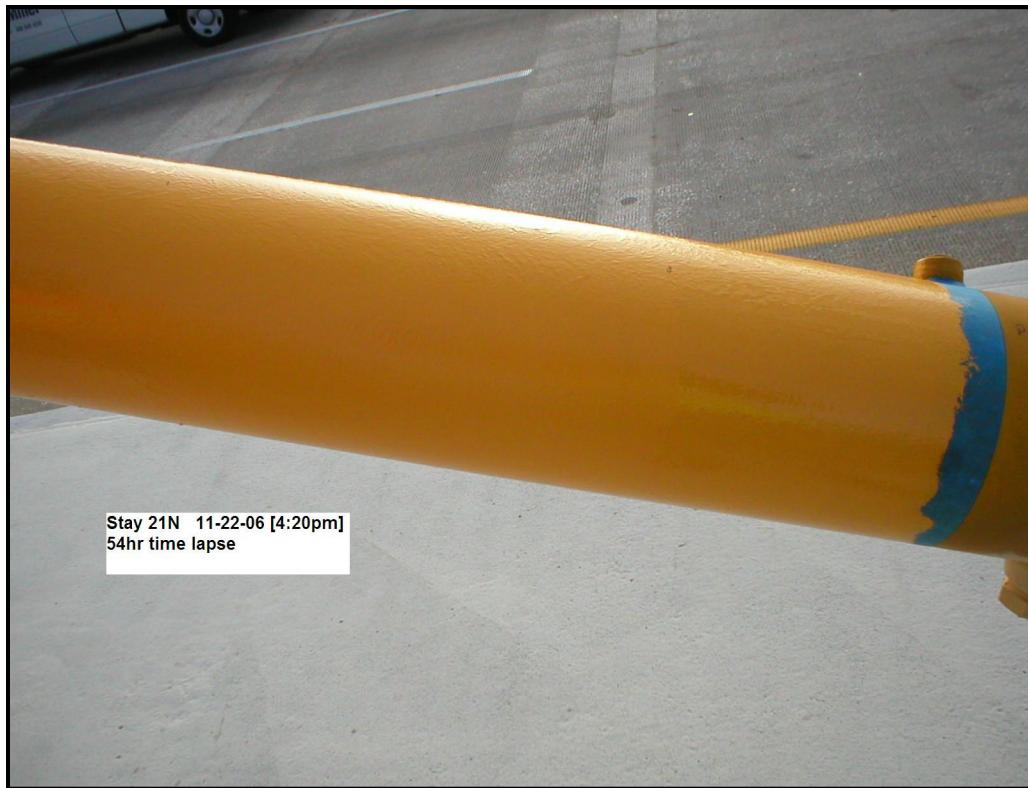
Figure 9 – 54 hour time lapse for dye dissipation.

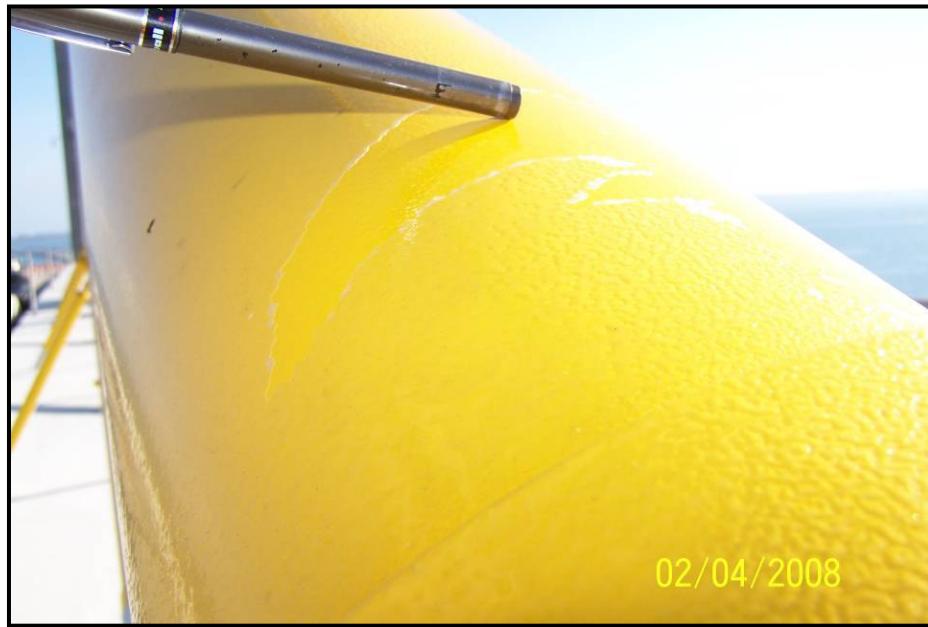
The first clear coat application on the lower stays was too thick because the contractor tried to make sure the clear coated surface was totally blue during application. The overly thick clear coat had clarity problems causing the film to appear cloudy after cure. After test applications in the field, the team found that only one pass was required to build the proper thickness and the clear coat film thickness was controlled well after that. Due to the project schedule, the lower stays were left to weather while the upper portions were finished.

After the weathering process, occurred adhesion problems with the clear coat had taken place on the lower stays. Figure 10 shows the poor adhesion to the finish color coat and cloudy appearance. FDOT requested that both the coating manufacturer and the CEI team investigate the cause of poor adhesion. Ultimately, despite all reports from the project that indicated that the ambient conditions were within the specified ranges during mixing and application, it was determined that the clear coat was applied over moisture. Numerous bubbles and voids in the film were consistent with moisture being involved. See Figure 11 for a microscopic view of the failing coating. The manufacturer postulated that the moisture was likely from non-visible, hydroscopic contaminants on the surface. Future applications required that the contractor check the surface for soluble salts ($7\text{ug}/\text{cm}^2$ maximum) and to wipe down the surface with acetone just before application of the clear coat. This procedure solved the adhesion problem.

Figure 10- Note the clear pulling away and the thickness and cloudy appearance of the coating.

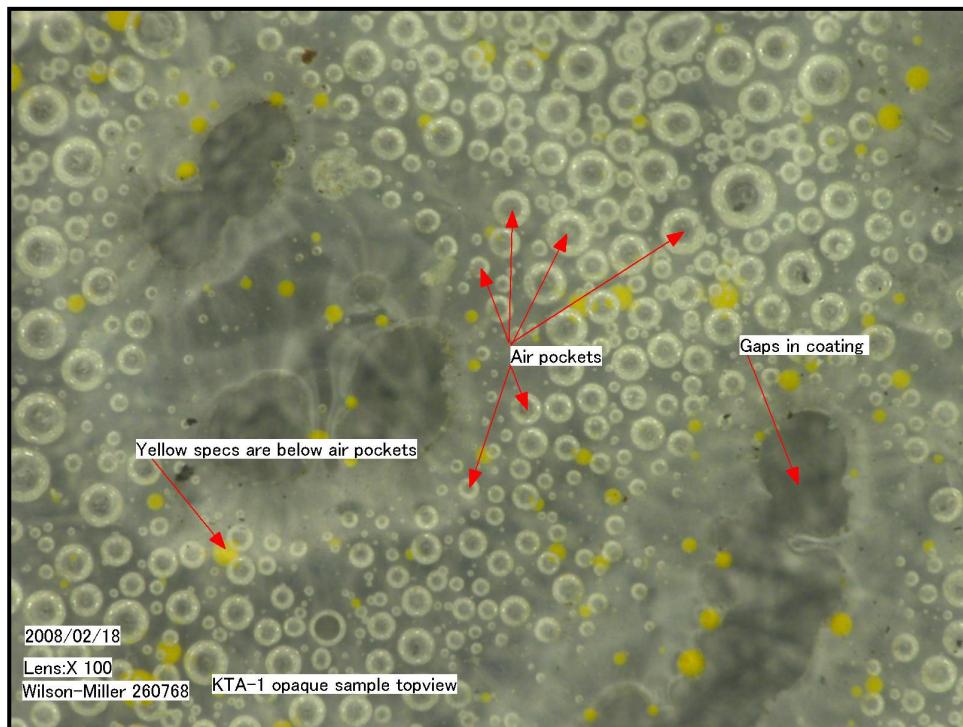
Figure 11- Microscopic view of failing clear coat.
